ARCHAEOLOGICAL, HISTORICAL and ARCHITECTURAL
EVALUATION
of the
CANTRELL WAREHOUSE/ENTERPRISE MILL
STATE SITE 7S-E-37
STEIN HIGHWAY, SEAFORD, SUSSEX COUNTY, DELAWARE

ARCHEOLOGICAL, HISTORICAL & ARCHITECTURAL EVALUATION
OF THE
CANTRELL WAREHOUSE/ENTERPRISE MILL
STATE NO. 7S-E-37, CRS NO. S-2227
STEIN HIGHWAY, SEAFORD, SUSSEX COUNTY, DELAWARE

DELDOT PROJECT #79-021-05 P.E. ARCHEOLOGY SERIES NO. 33
FHWA FEDERAL AID PROJECT F-1010(3)

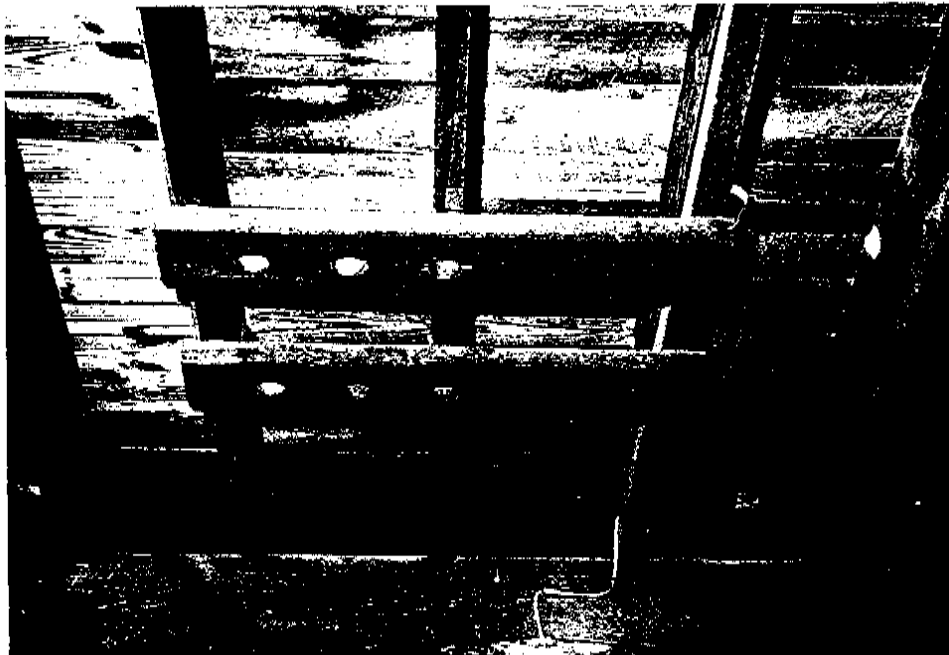
PLATE 12

DETAIL - MACHINE MOUNT

Although it is beyond the remains of the extant structure to provide an engineering study of the mill operation, some vestiges of that operation remain. Portions of the floorboards of both the first and second floor have been replaced and holes in the floors have been patched, some of which certainly were part of the mill operation. Although materials being stored in the mill probably prevented locating all such vestiges of the operation, those visible have been mapped and are shown on Figures 26 and 27. Also to be noted on these figures are items related to the mill operation which are visible from the floor below that which the figure represents. Specifically, some remains of the top portions of gravity chutes (e.g. Plate 11) by which grain was moved from the second floor to the mill stones and/or rollers on the first floor are visible when looking up from the first floor. Similarly visible are boards which have been bolted or nailed to the joists of both the first and second floors (e.g. Plate 12). These probably served as machinery mounts. Although some of

these boards are plain and probably served only as structural supports for machinery, others have holes drilled in them which possibly served as guides for turning axles.

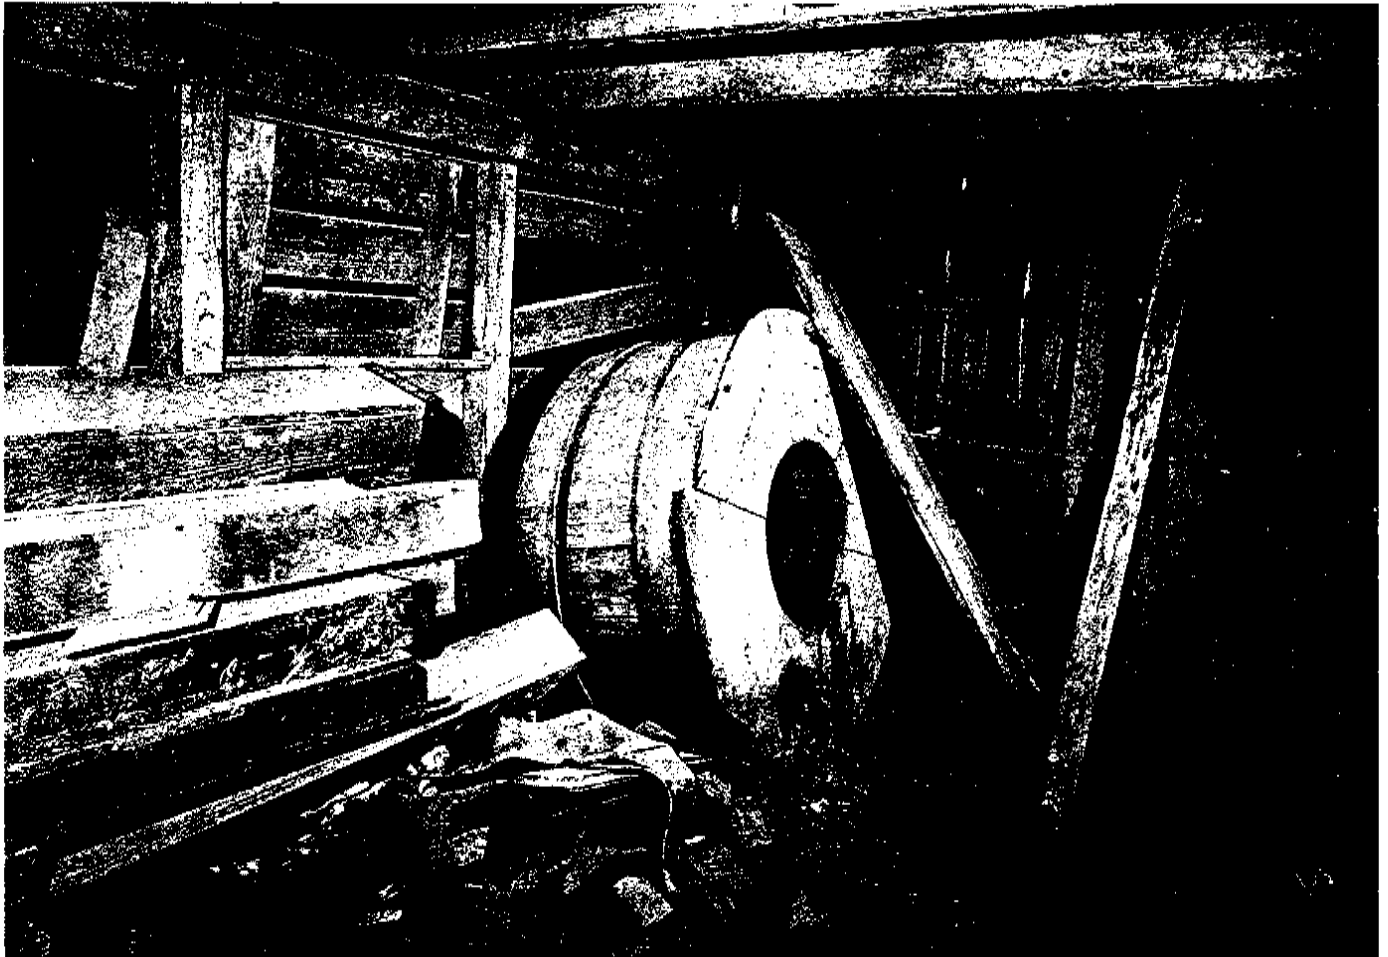
PLATE 15

MILL OPERATION
EQUIPMENT REMAINS

Although the barn located at the rear of the project property (Figure 29) was not recorded architecturally, it was investigated and photographed (Plates 13, 14). The braced frame barn is a one-and-one-half story structure, suggesting that the second story was used for storage and that it therefore might be the "grainary" mentioned in a 1920 deed (222-201). Although the second story of the barn is vacant, the first floor and the attached lean-to shed are used as storage space for parts of the original mill workings (e.g. Plate 15) primarily those made of wood. These include a vat which enclosed a millstone, an

extensive amount of wooden chuting, a hopper, a probable flour dresser, fabric belt and metal cup grain elevators, wooden pulleys, portions of large tenoned beams, and several pieces of metal machinery. The workings listed all appear to be in excellent condition and others lie buried between them and the dirt floor of the barn.
